Geomorphology Appendix

Prescott Creeks Preservation Association Watson Woods Riparian Preserve Restoration Project Final Report

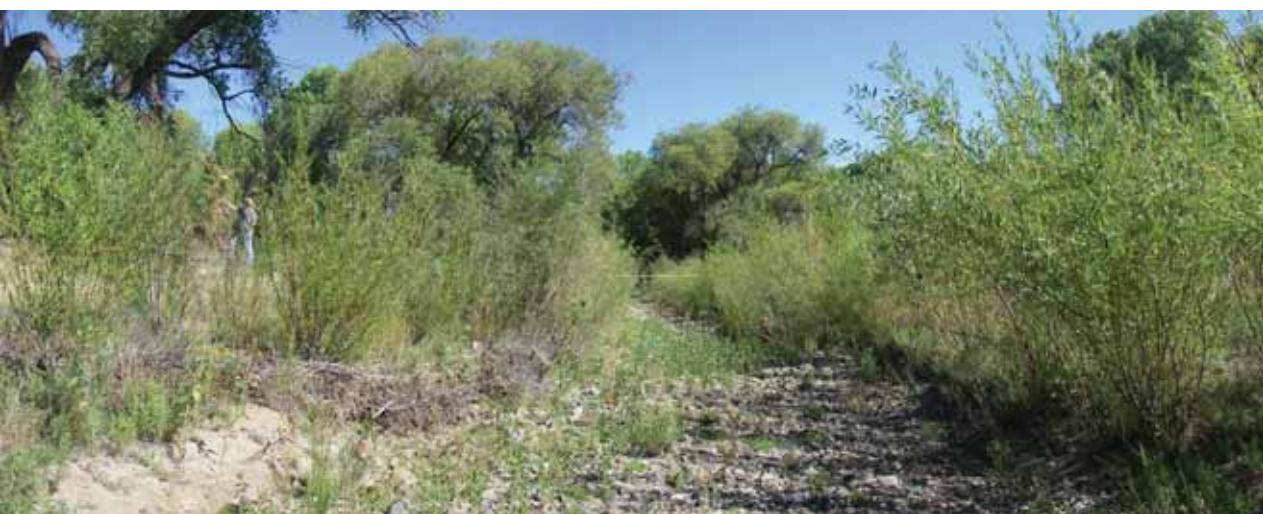
Figure A 28: Channel cross-section 5 photo taken October 2010. *Erosion on the right bank can't be seen in the photos due to the density of the willows.*

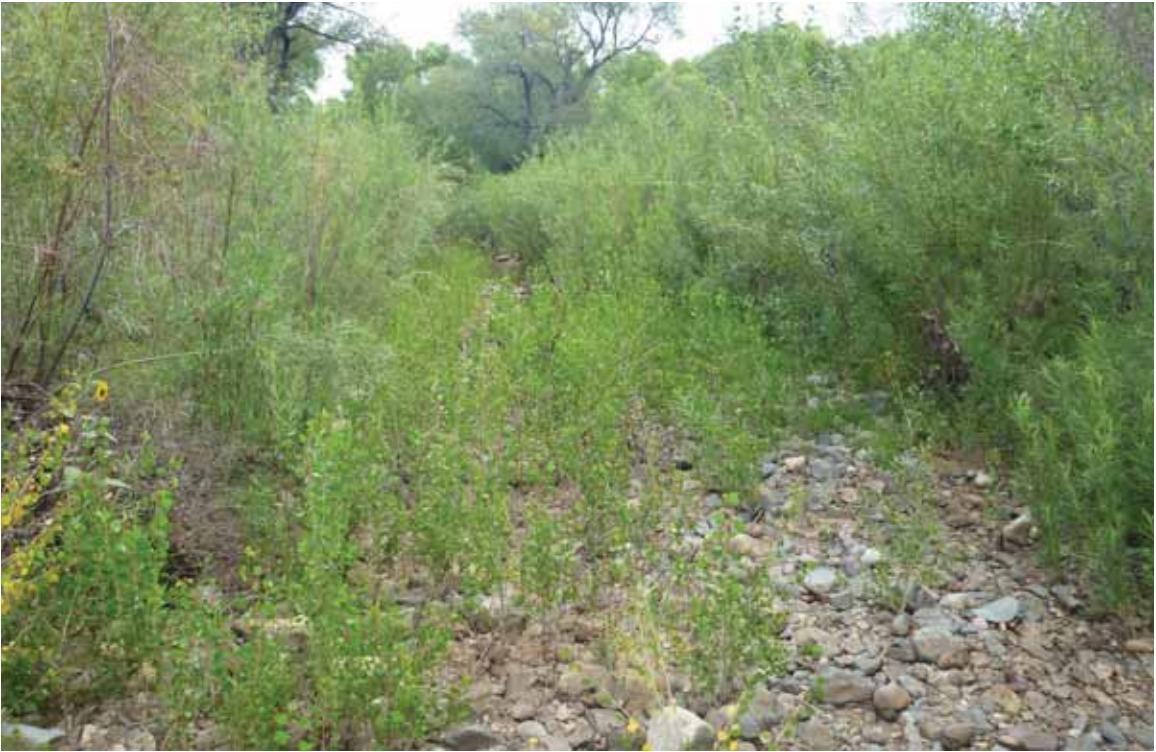
Figure A 29: Channel cross-section 5 photo taken September 2011.

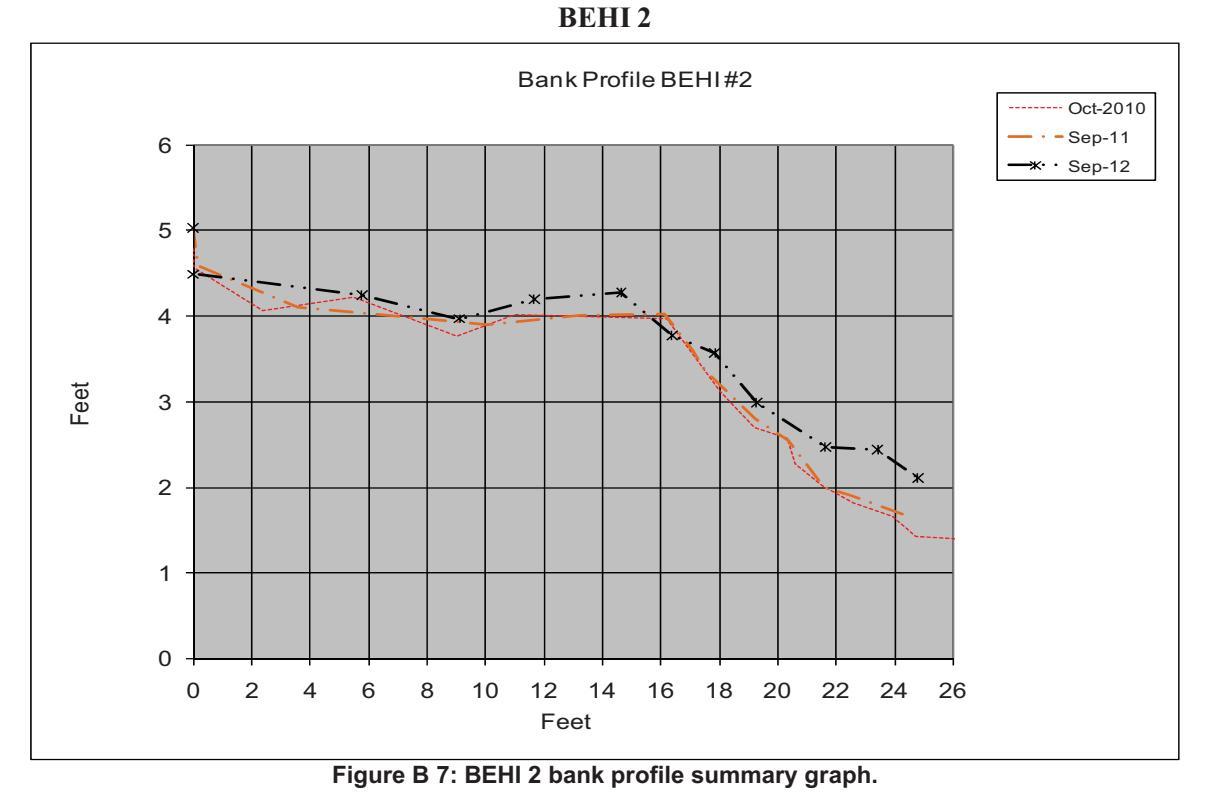
Cross section for 2012 does not line up correctly due to missing pin on right bank. No apparent erosion has occurred at this bank. BEHI Values are still valid.

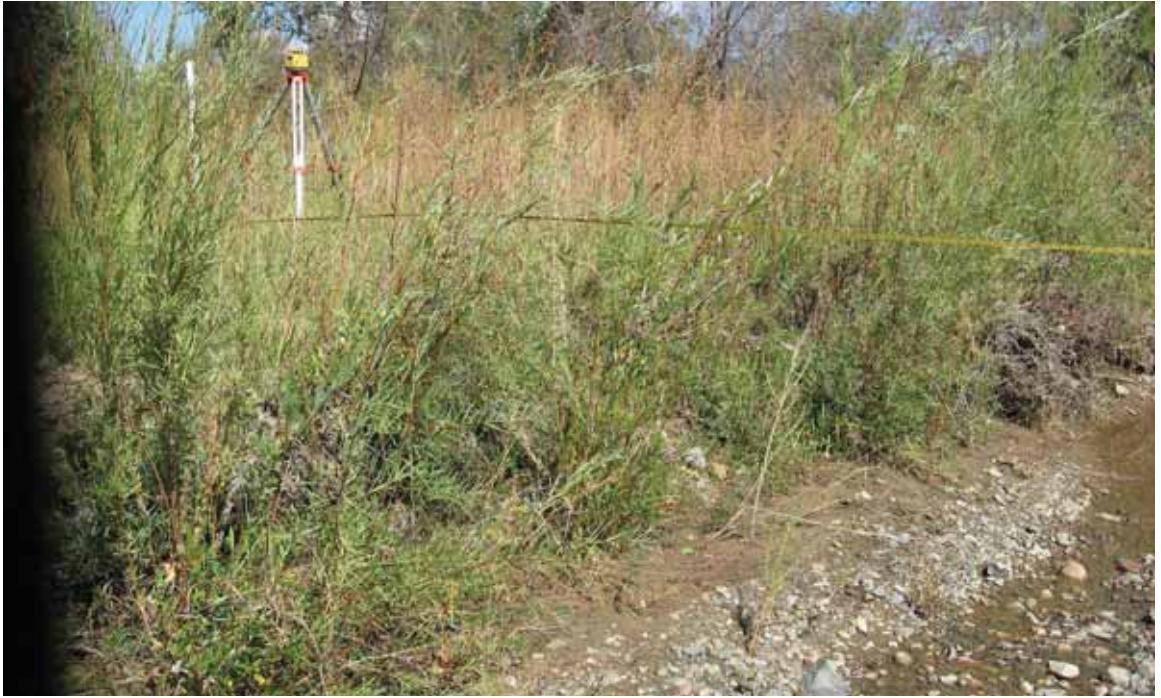
Figure B 10: BEHI 2 photo taken October 2010.

There has been minor erosion on the bank between willows along with aggradation along the toe of the bank. Overall this bank is responded well to the revegetation and stabilization efforts. The channel at this BEHI location is no longer the main channel, but acts as an overflow channel conveying flood waters.

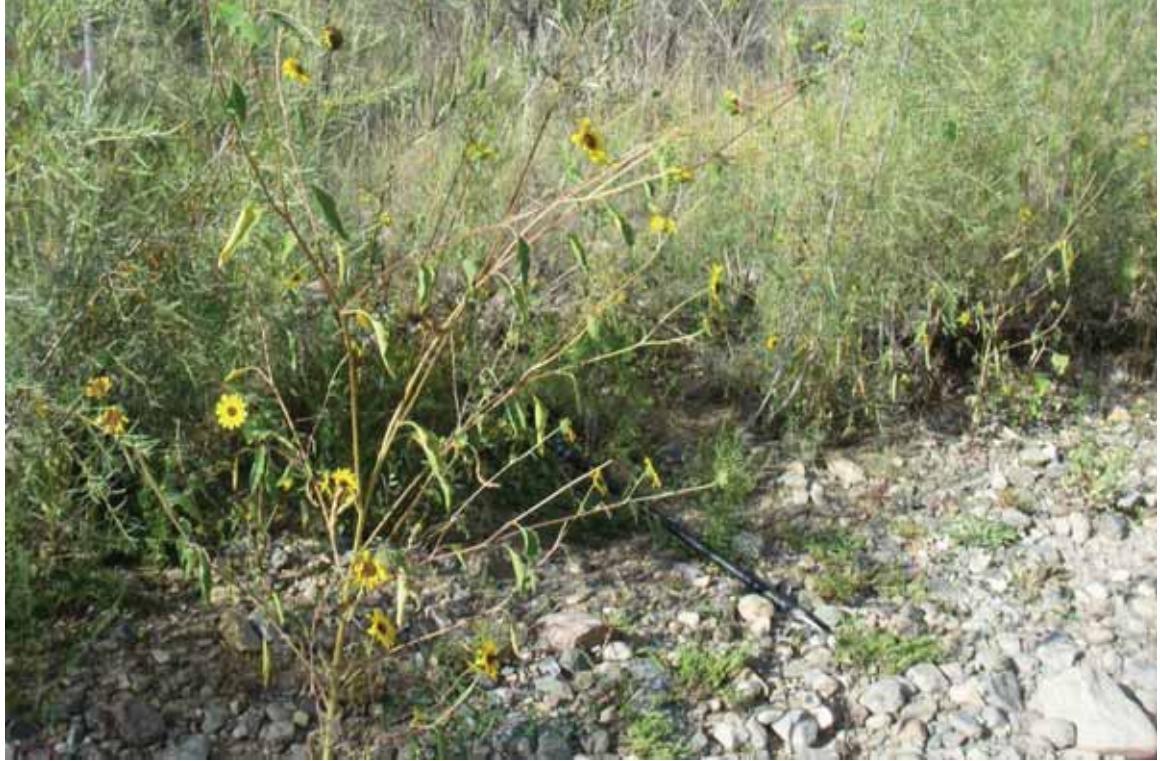
Figure B 11: BEHI 2 photo taken September 2011.

Lower flows in 2011 have removed some of the fine sediment from the bed as seen in the 2010 photo.

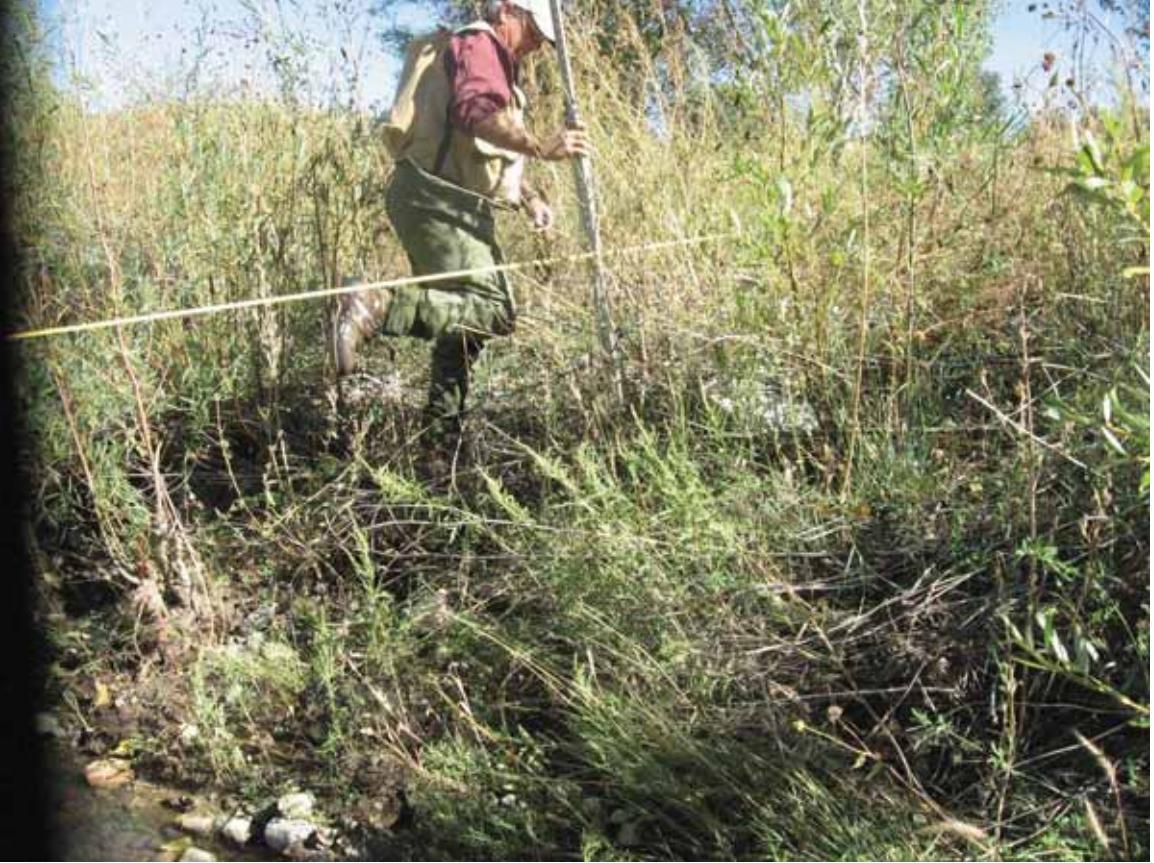
Figure B 20: BEHI 4, October 2010

There has been some channel bed adjustment as the finer bed material gets removed by the higher flows.

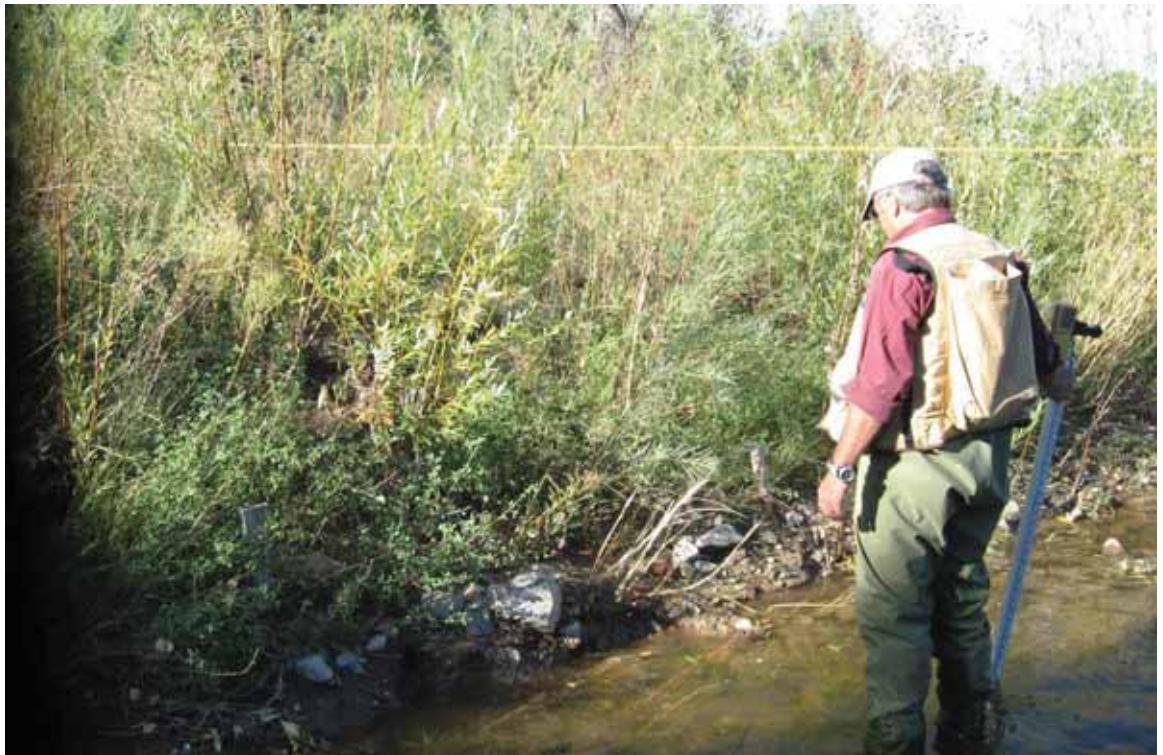
Figure B 26: BEHI 5 photo taken October 2010.

The channel bed has adjusted a little at this location as the finer bed material gets removed by higher flows. There should be little further adjustment as the channel evolves.

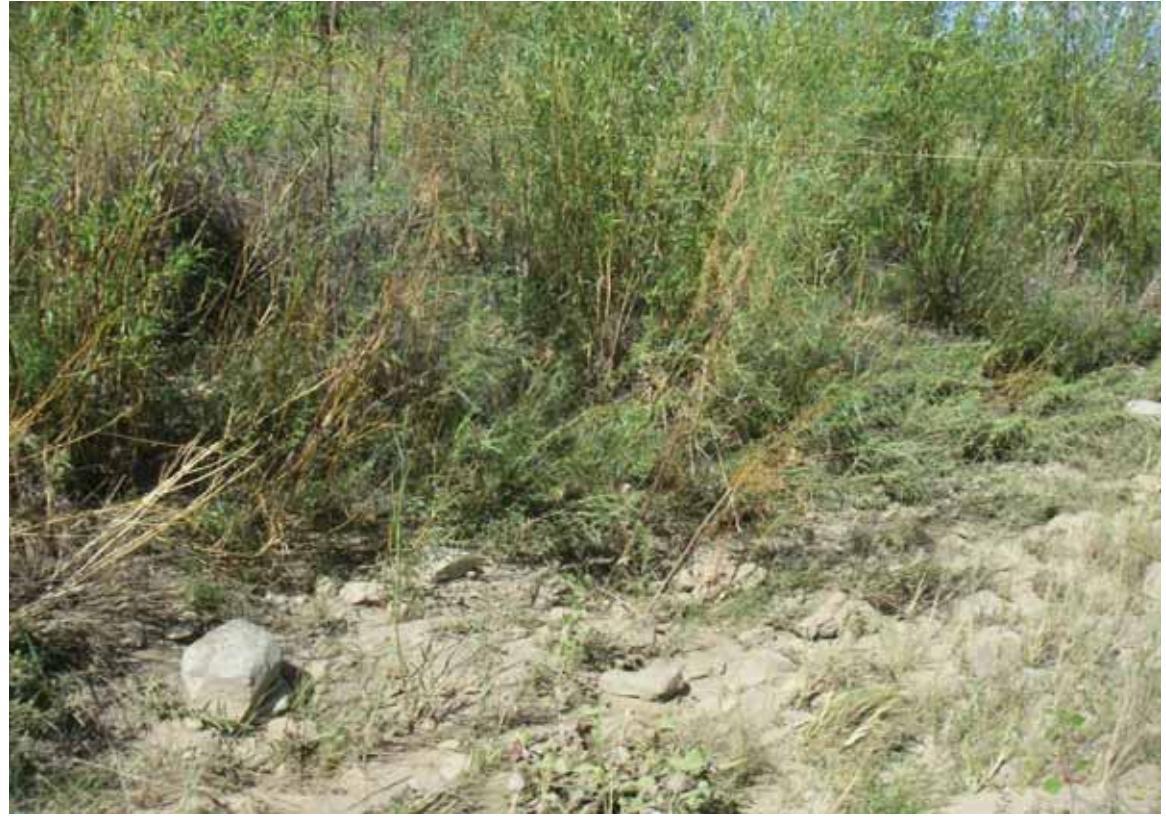
Figure B 27: BEHI 5 photo taken September 2011.

Vegetation is lying over due to previous weeks flow.

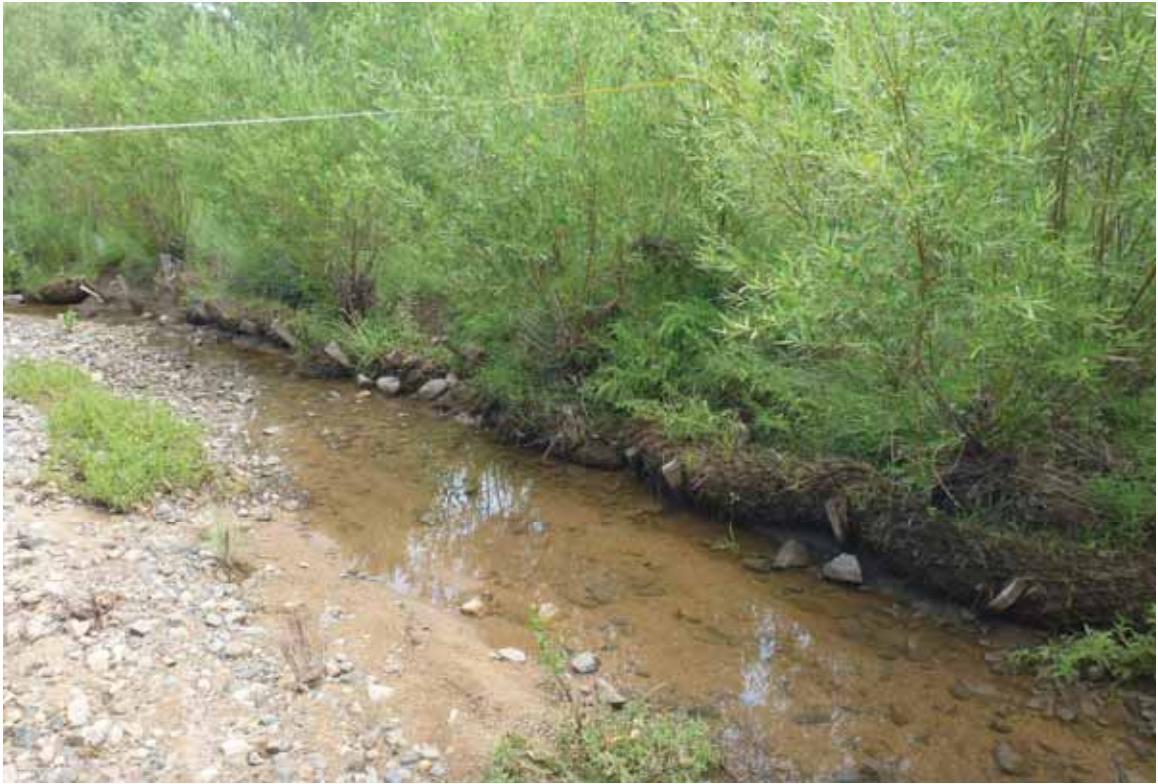
Figure B 33: BEHI 6 photo taken September 2012.

Coir log at toe of bank has been replaced.

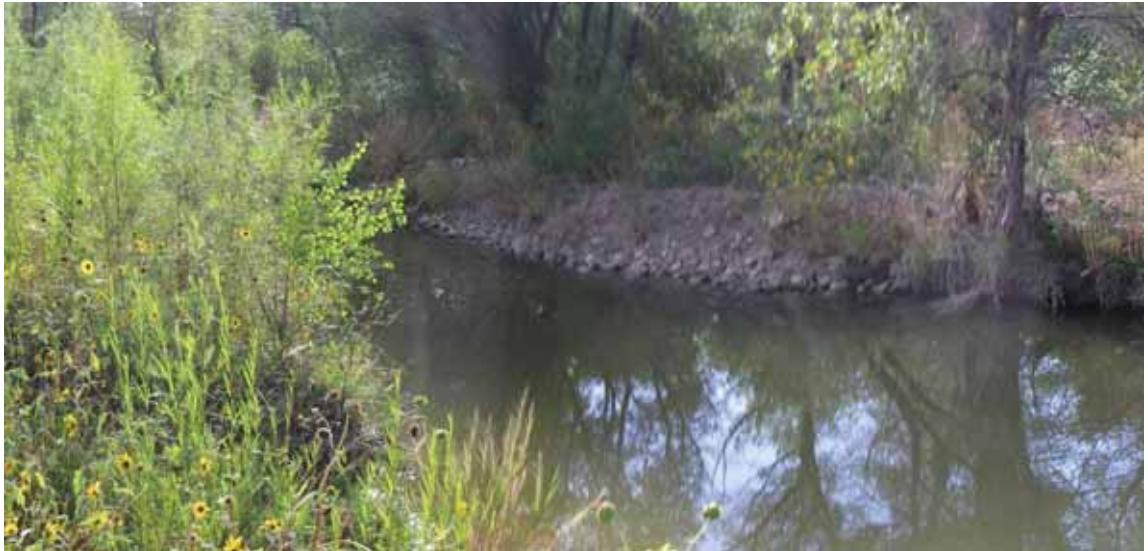
Figure C 3: Upstream from PP-1, Reach 1 taken October 2010. *Willow growth on the near bank will eventually obscure the view from this photo point.*

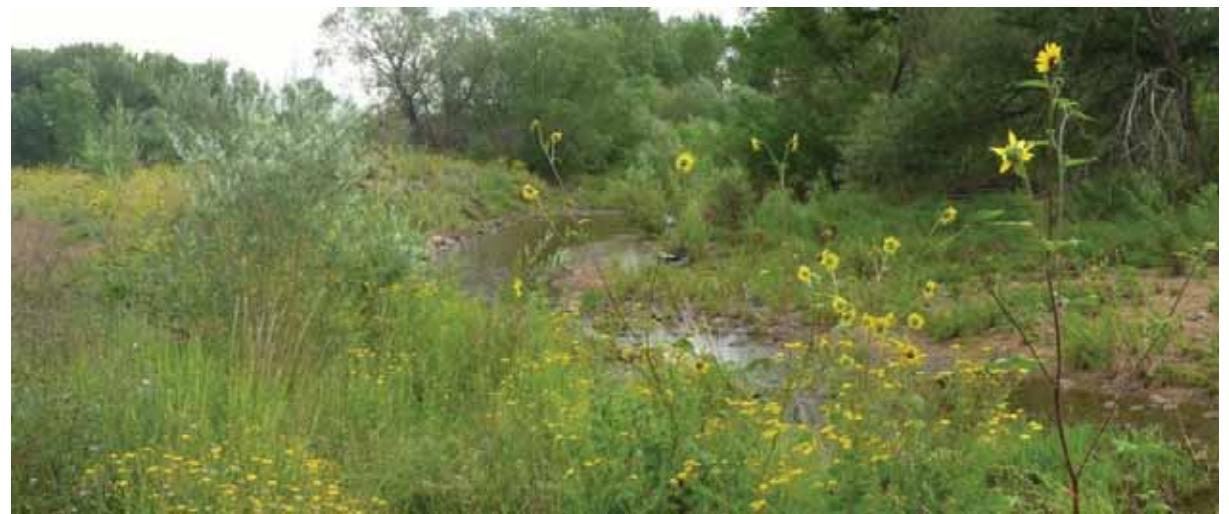
Figure C 29: Looking downstream from PP-3, taken September 2011.
