Macroinvertebrate Zoology Appendix

- Appendix A – Monitoring Station Locations
- Appendix B – Multi-Habitat Sampling Method
- Appendix C – Table of Habitat Data from Samples
- Appendix D – Habitat Assessment Reports
- Appendix E – Bioassessment Reports
- Appendix F – Metric and IBI Scores

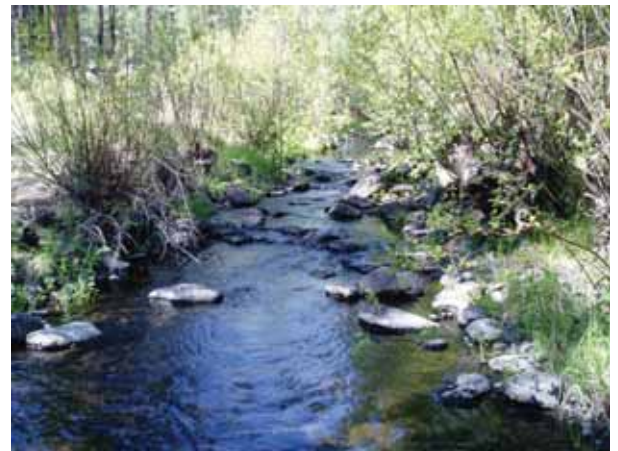
- Rocky-bottom approach applies where:
 - Channel substrate is primarily gravel, cobble, or boulders; and
 - Stream segments are primarily riffle and run habitats
- Muddy-bottom approach applies where:
 - Stream flow is slow moving or has dried to large pools of water;
 - Channel substrate is muddy, silty, or sandy;
 - Stream segments have little to no riffles; or
 - Channel bottom is flat.

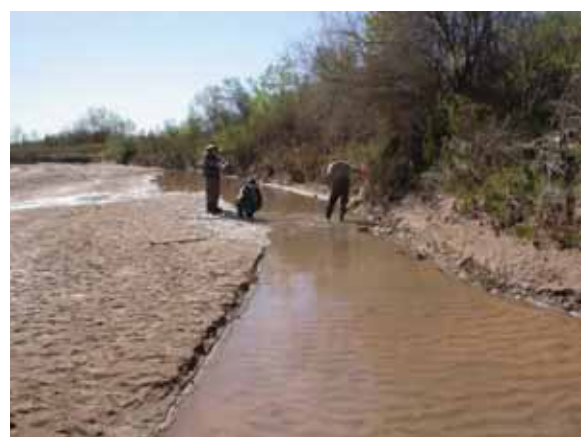
- Vegetative bank margins – Consisting of overhanging bank vegetation and submerged root mats attached to banks. This is often the most abundant type of habitat.

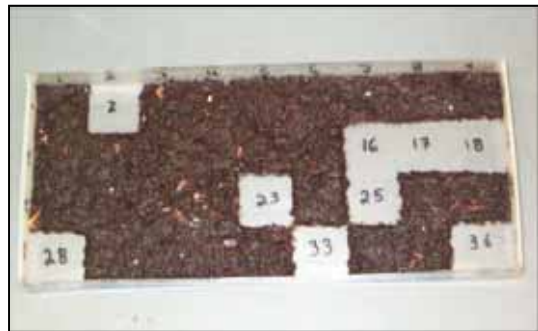
Caton Tray Sub-sampling

Sub-sampling – Arizona samples typically contain thousands of invertebrates so they must be sub-sampled to limit the counts to between 500-600 organisms. A Caton Tray is used to randomly obtain fractions of the total sample for counting. Spread the sample out across a Caton Tray and randomly select a section (1/30th of the sample). Additional fractions are selected until the 500-600 organisms have been identified. Additional fractions are exemplified if one fraction is dominated by a single species. After the target number of specimens has been achieved, the rest of the sample (the unsorted portion) is scanned for large or rare taxa, which may aid in identification of smaller instars or may expand the taxa list for that sample.

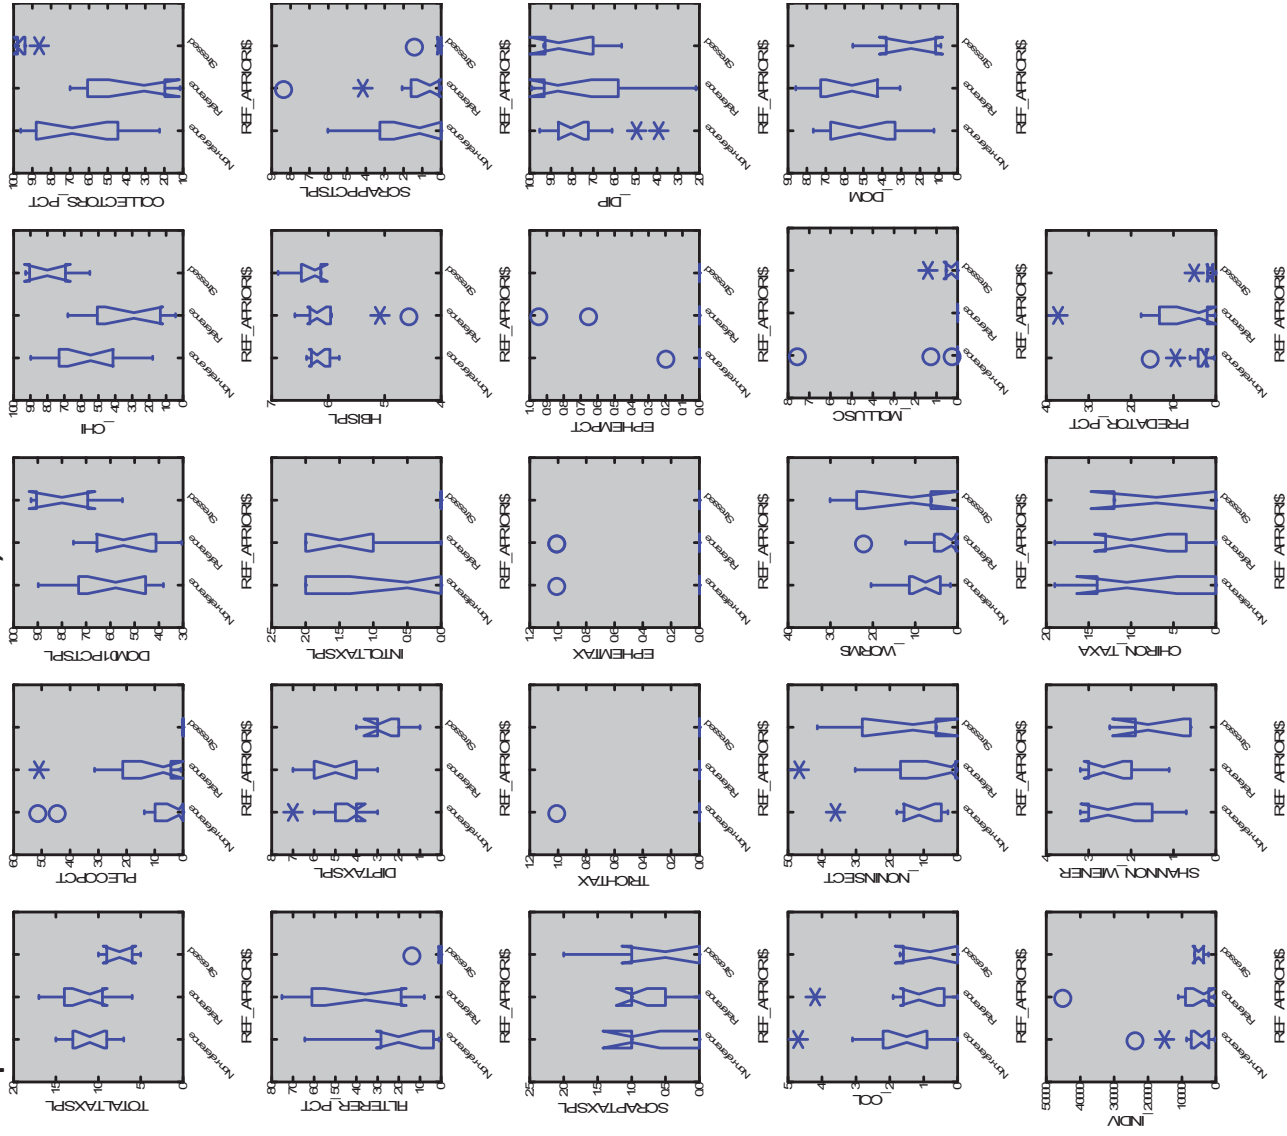
Appendix G: Box and whisker plots of various macroinvertebrate metrics tested for ability to discriminate between reference and stressed samples in intermittent streams of Arizona, 2008-2011.
