Geomorphology Appendix

Prescott Creeks Preservation Association Watson Woods Riparian Preserve Restoration Project Final Report

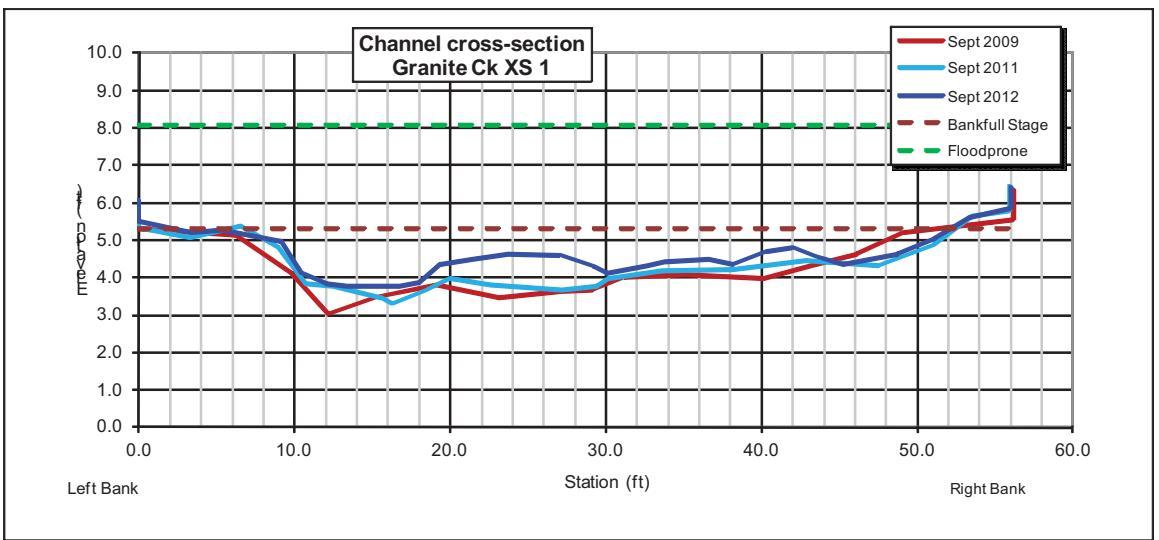
Figure A 1: Channel cross-section 1 summary graph.

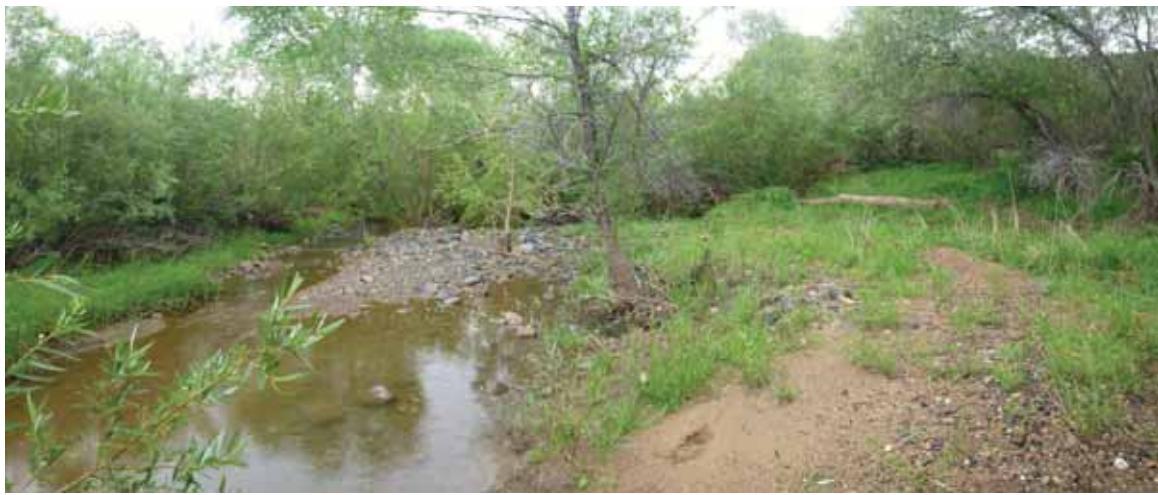
Figure A 6: Channel cross-section 1 photo taken September 2012

Sediment has accumulated upstream from the willow in the channel, especially since the flood of last year.

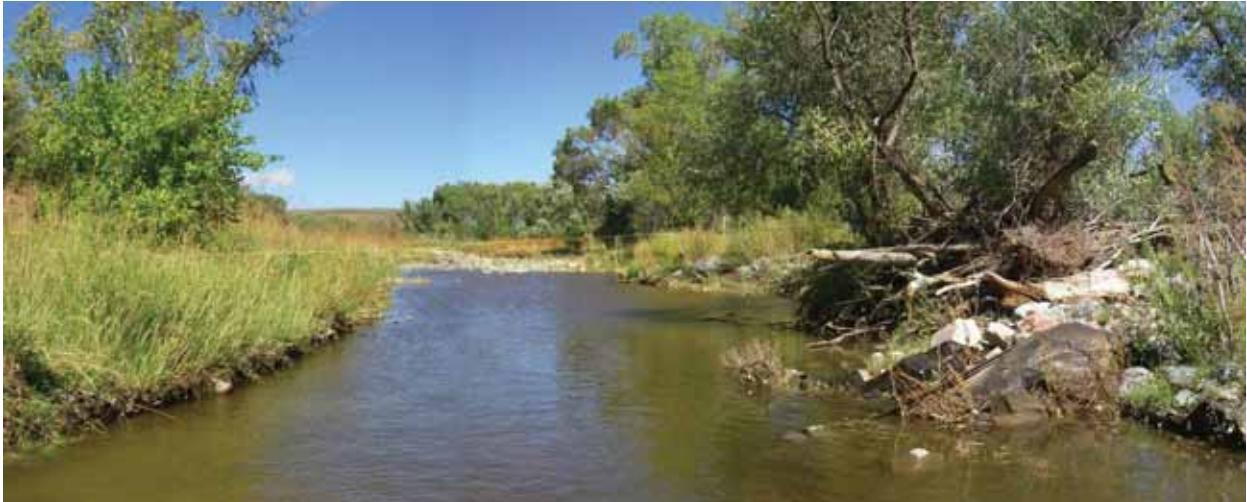
Figure A 10: Channel cross-section 2 photo taken October 2010. *Note the flood debris piled against the trees on the right bank is from the January flood.*

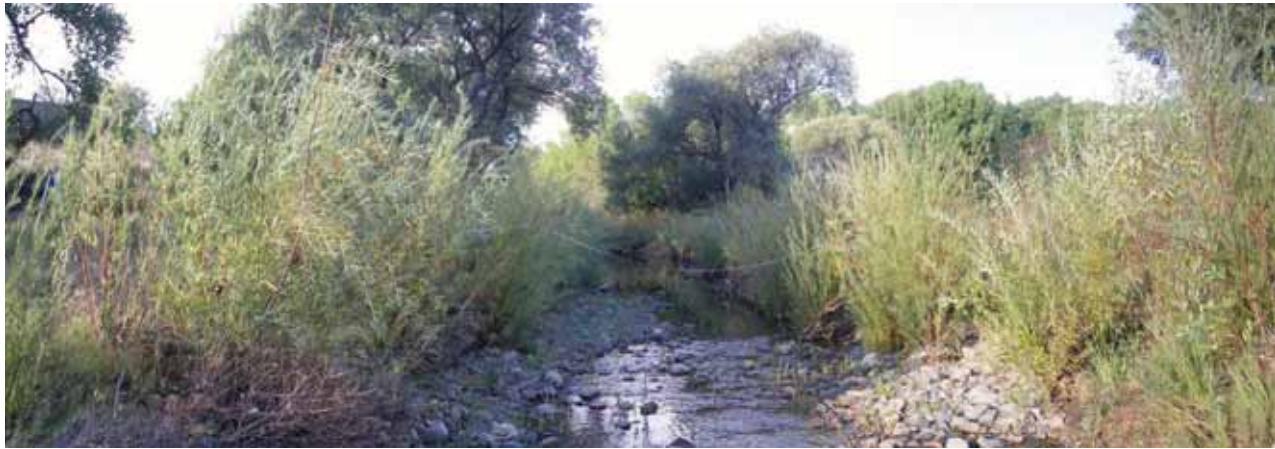
Figure A 28: Channel cross-section 5 photo taken October 2010. *Erosion on the right bank can't be seen in the photos due to the density of the willows.*

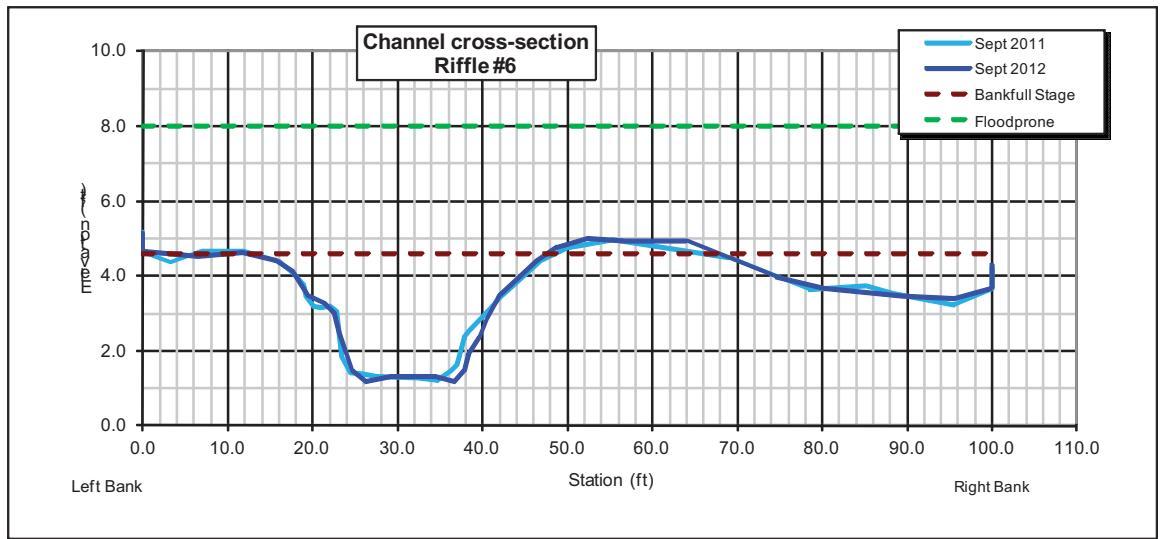
Figure A 31: Channel cross-section 6 summary graph.

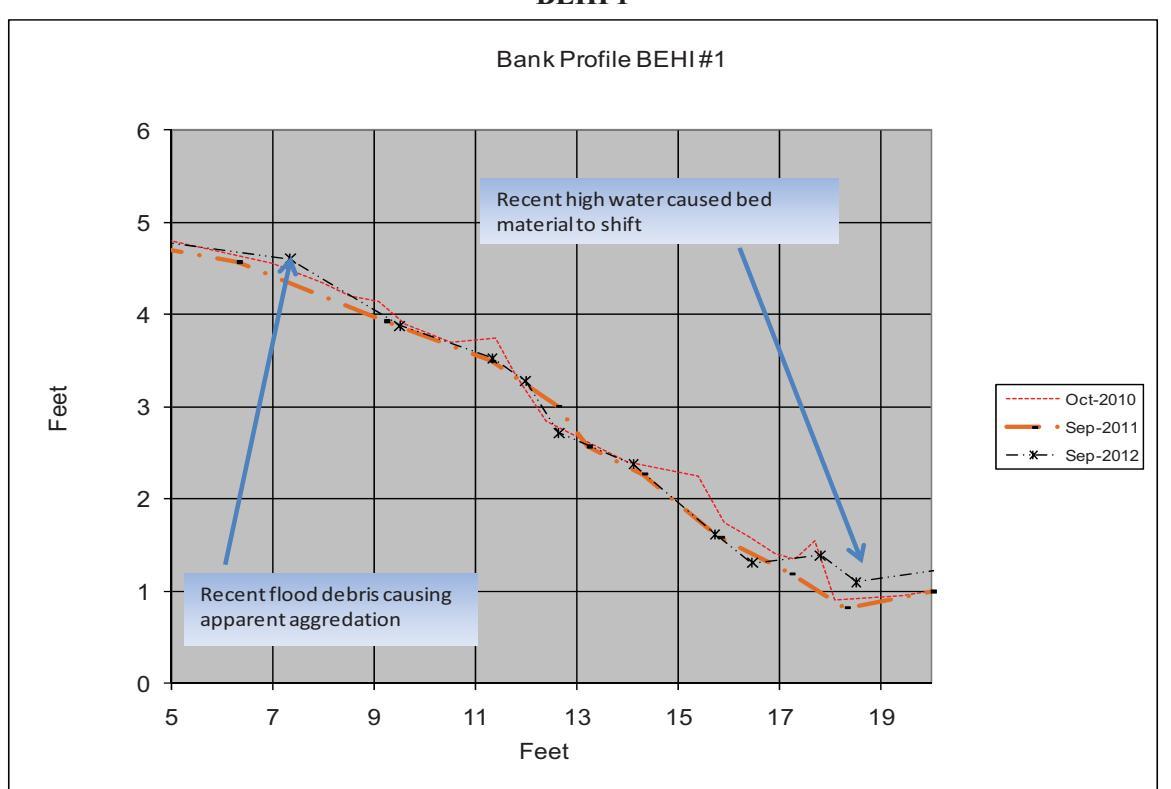
BEHI 1

Left pin was bent was bent over.

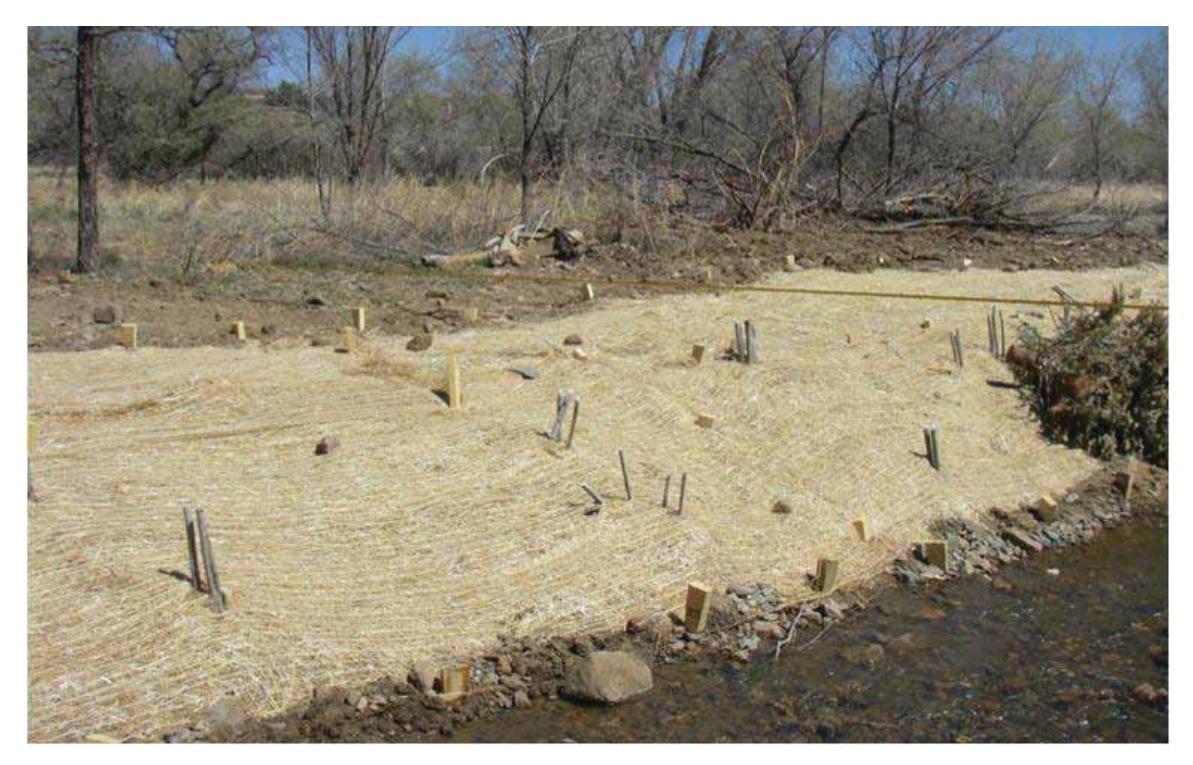
Cross section for 2012 does not line up correctly due to missing pin on right bank. No apparent erosion has occurred at this bank. BEHI Values are still valid.

Figure B 8: BEHI 2 photo taken April 2009.

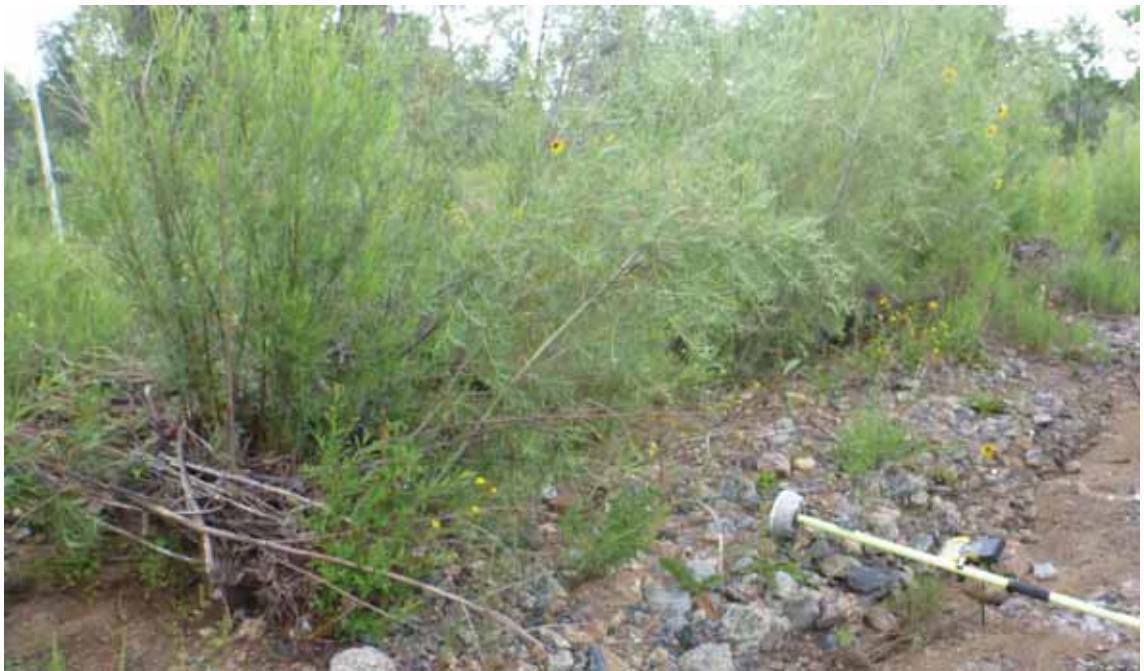
Figure B 12 BEHI 2 photo taken September 2012.

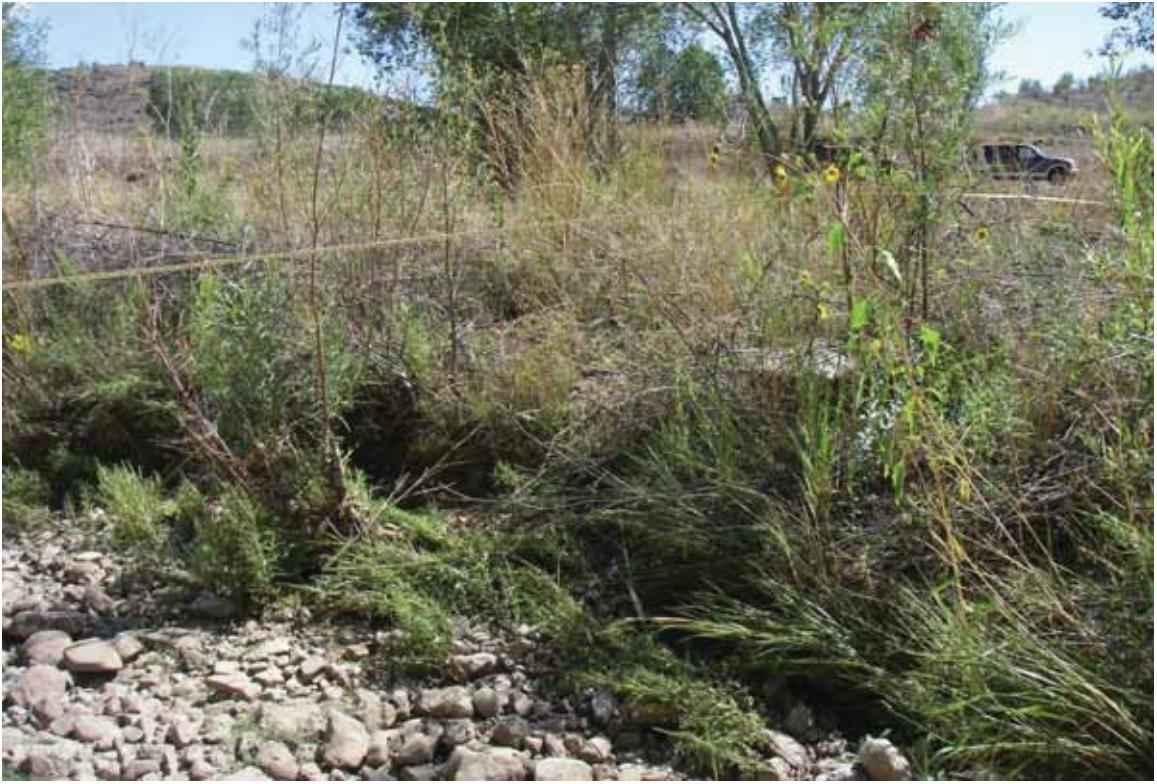
Figure B 21: BEHI 4 September 2011.

Vegetation in general is less dense this year due to drought conditions.

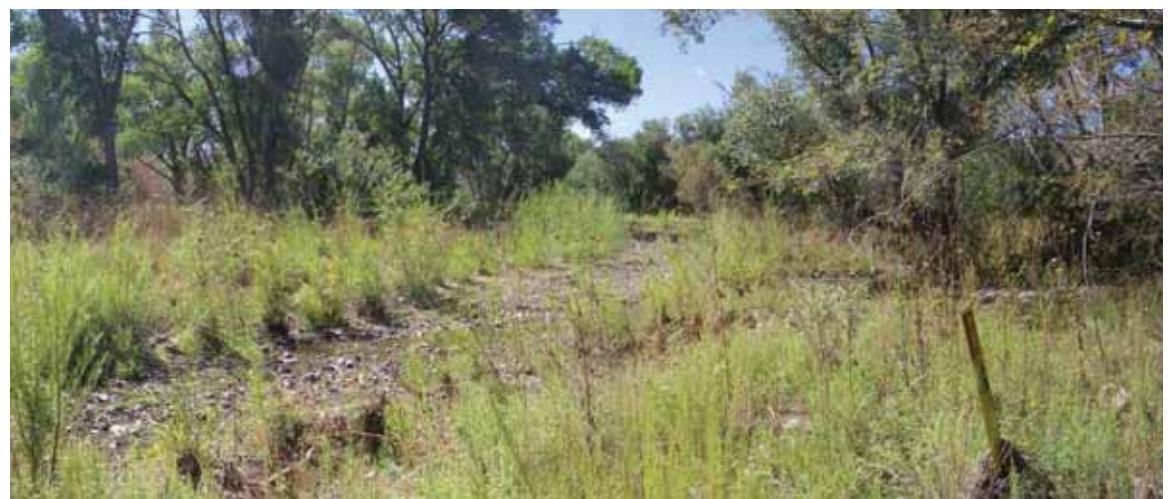
Figure C 13: Upstream from PP-2, Reach 1 taken October 2010.

This channel is no longer the main channel, but flows at above bankfull events.

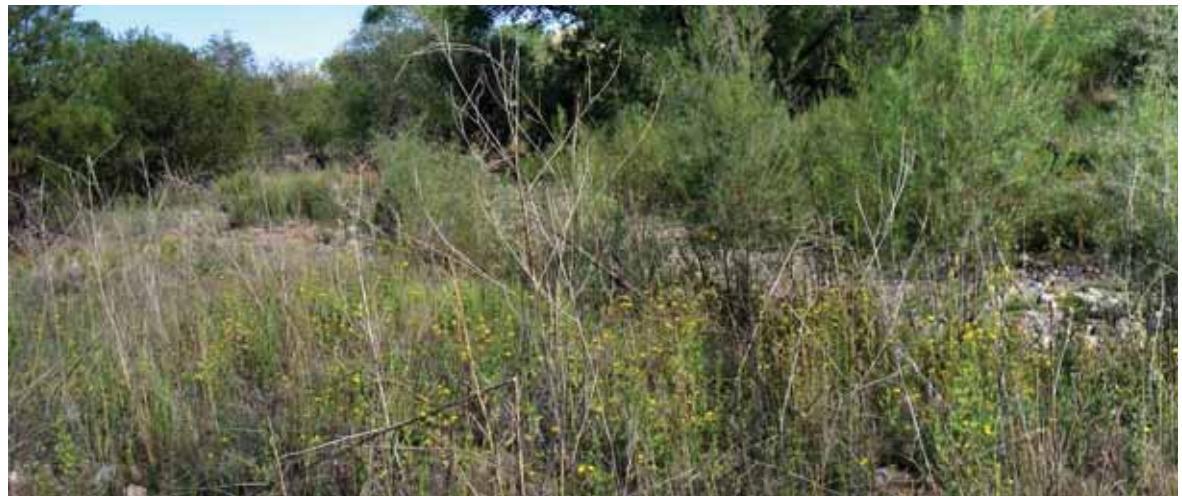
Figure C 19: Looking downstream from PP2, taken September 2011.

Sunflowers were not as prevalent as last year.

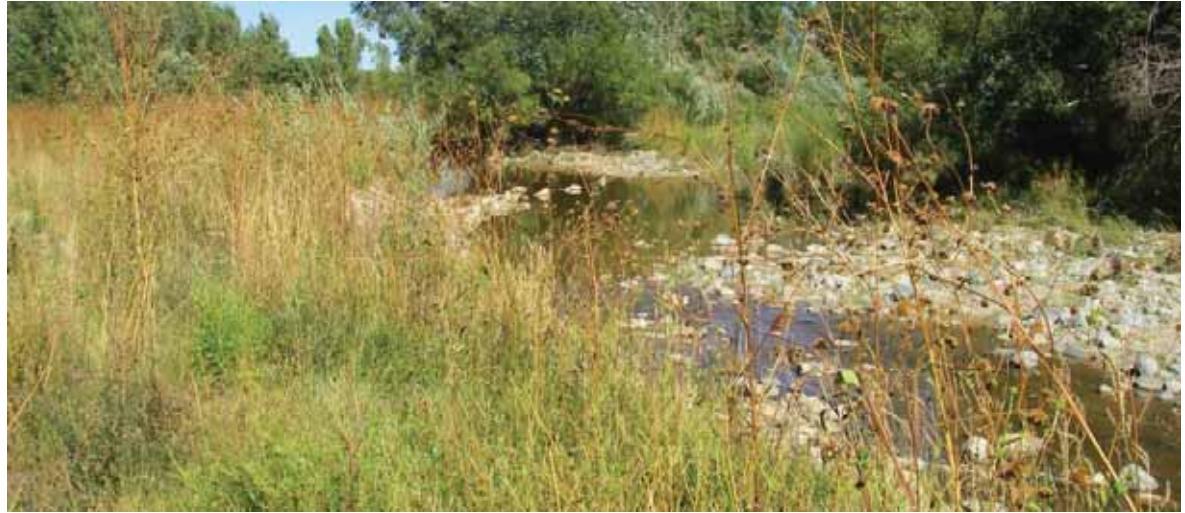
Figure C 28: Looking downstream from PP-3, taken October 2010.

The downstream end of the rock was removed by high flows in January, 2010.

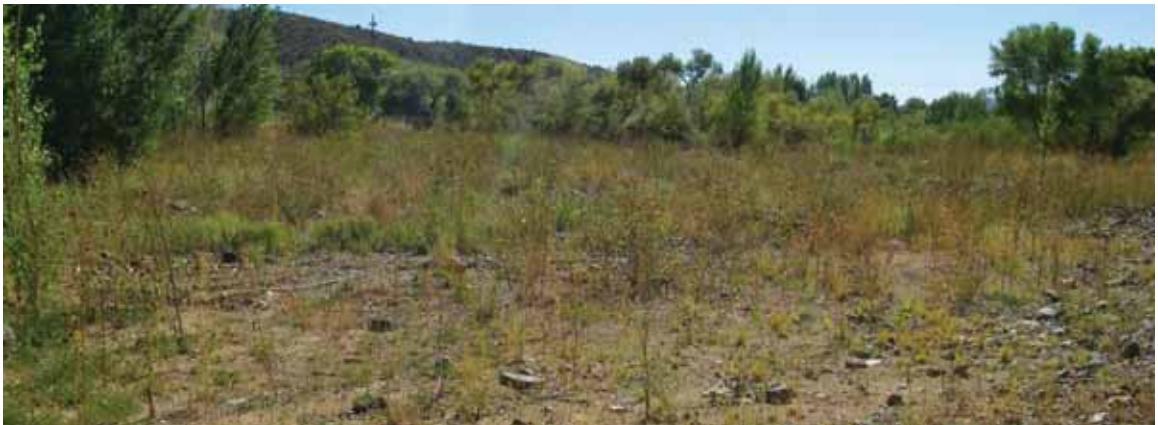
Figure C 38: Looking south from PP-5 taken October 2010.

High flows in January deposited sediment through here, erasing the construction scars.

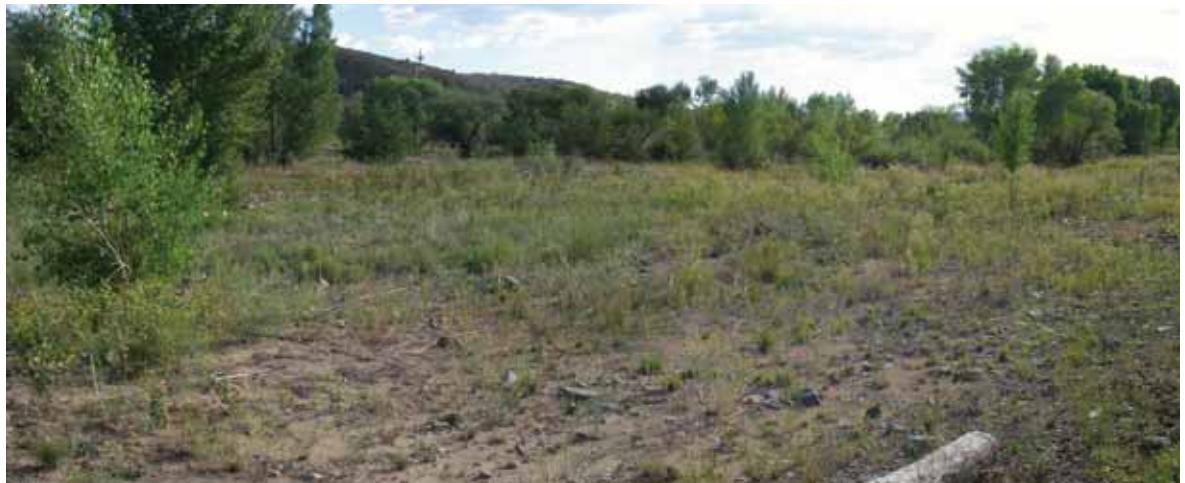
Figure C 39: Looking south from PP-5, taken September 2011.

Several planted cottonwood trees can be seen growing in these photos.

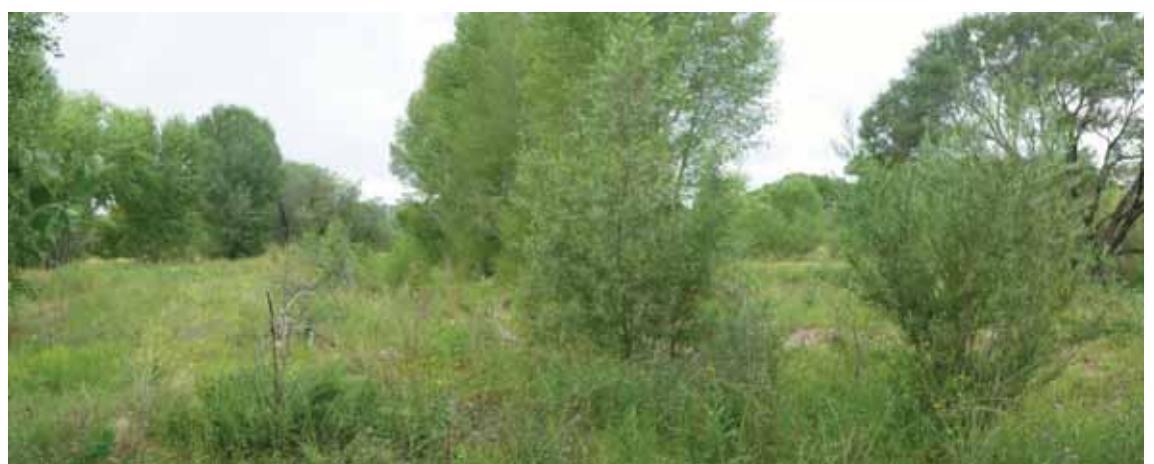
Figure C 45: Looking upstream from PP-6 taken September 2012. Vegetation obscures the channel in these photos.

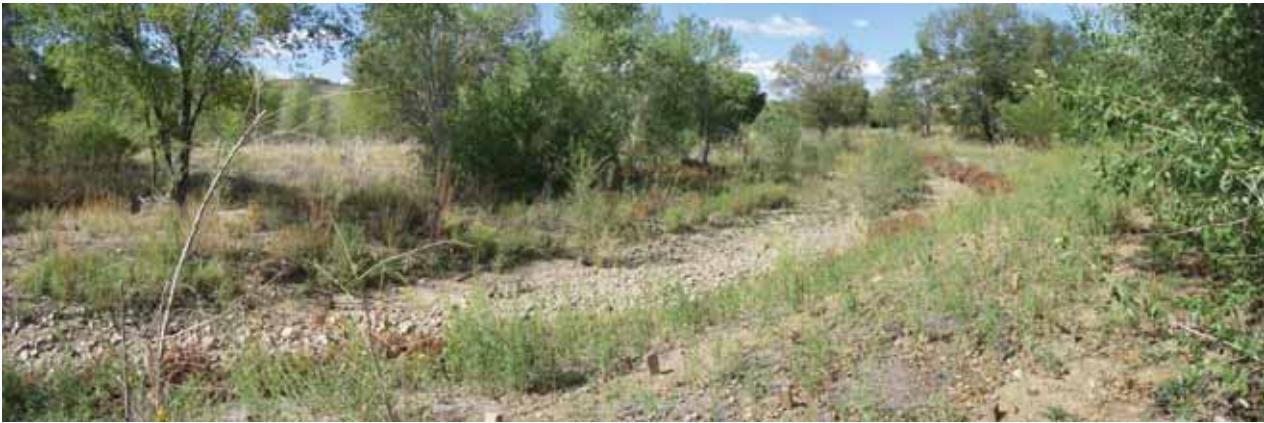
Figure C 49: Looking downstream from PP-6, taken September 2011.

This bank was re-sloped in 2010, after the previous photo was taken. The bank is now closer to the photo point.

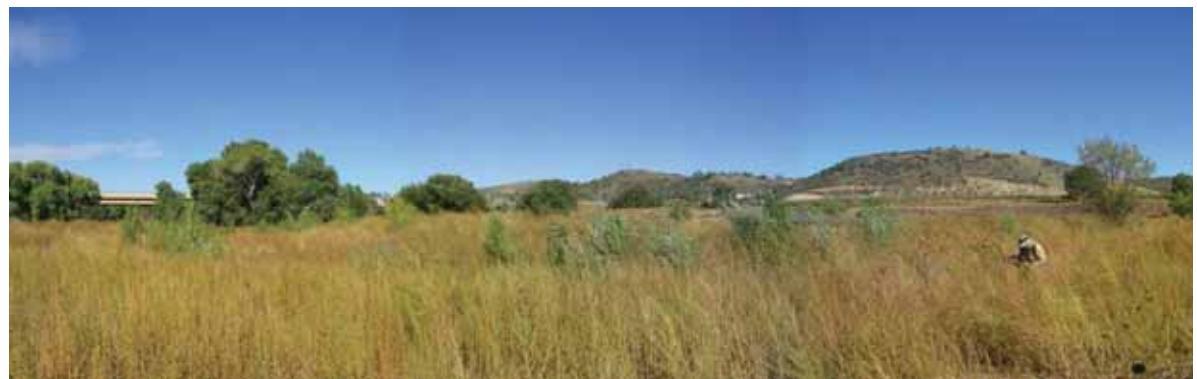
Figure C 53: Wetland 3 from PP-7, taken October 2010.

The planted cottonwoods can be seen in the recent photo, to the left of the person in the photo.

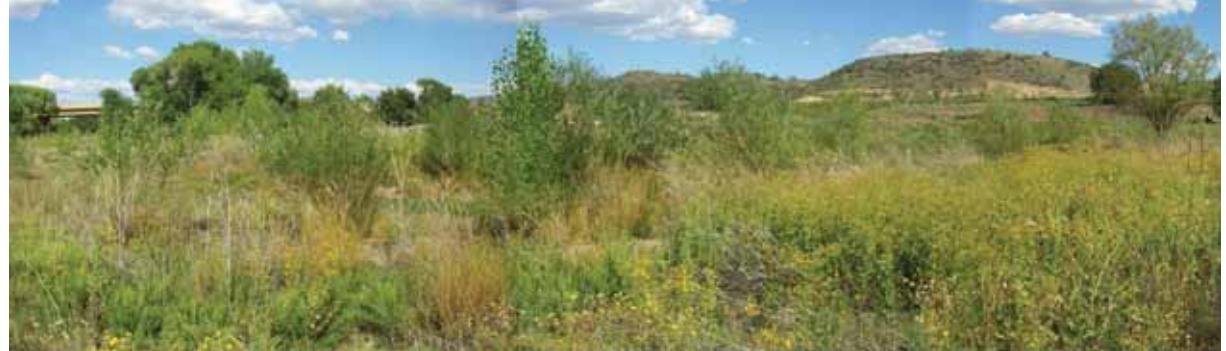
Figure C 54: Wetland 3 from PP-7, taken September 2011. Cottonwood plantings have begun to take off.

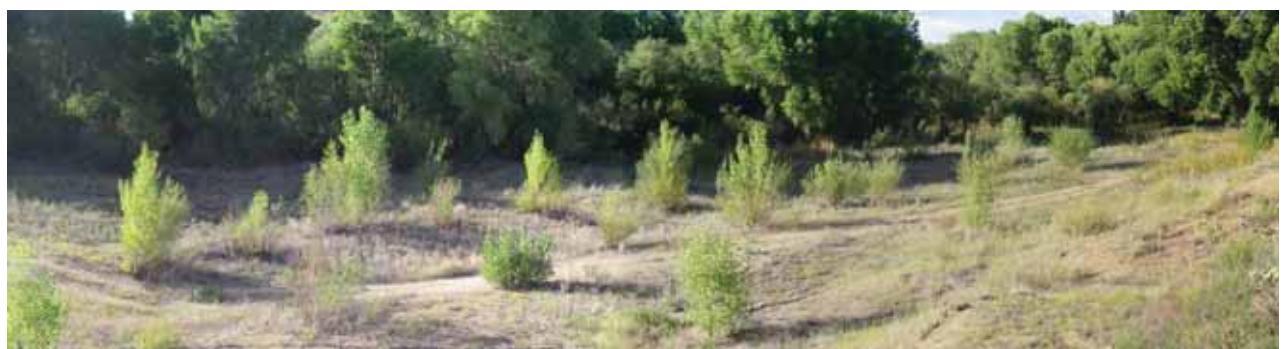
Figure C 74: Wetland 6 taken from PP-11, September 2011.

Planted cottonwoods are beginning to fill in.
